WHO Somalia

Floods in Burhakaba

1 November 2007

Situation analysis

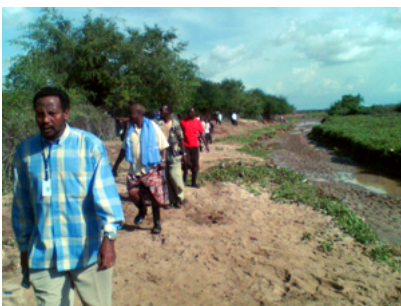
A canal dug by the local authorities in the Wadir section, with support from International Labour Organization (ILO), has been damaged. A more in-depth technical visit needs to be conducted to see how flooding of the canal can be prevented in future.

The Wadir canal, dug by ILO last September

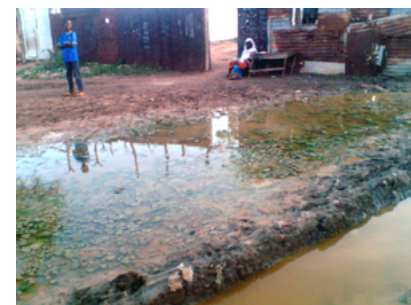
Heavy rains causing severe flooding in Burhakaba town have announced the beginning of the Deyr rainy season in Central South Somalia. As of 31 October 2007 Burhakaba town (about 64 KM from Baidoa) reported serious floods affecting Wadajir, Howlwadaaga, and Waberi sections.

Floods in Howlwadag section

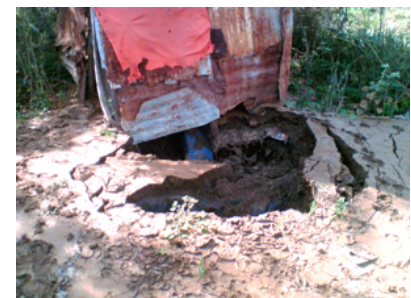
The floods damaged about 350-400 houses and a similar number of latrines. An initial prediction of the total number of affected families is between 700 and 800 families. Increased use of unsafe water catchments is a major concern.

Damaged latrines in Burhakaba

- Provide non foods items including jerry cans and Insecticide Treated Bed nets (ITN) to affected families
- Provide latrines and slaps to the 250-300 affected households
- Urgent household chlorination in Burhakaba district
- Review the main Burhakaba water catchment, provide a generator, and rehabilitate the water tank to reduce the contamination of drinking water and wastage.
